**Vickers Business Centre
ASBESTOS SURVEY REPORT
FOR**

**Vickers Business Centre,
Century House & one
Industrial Unit
Basingstoke**

Issue Number: 1
Project Number: TPN3143
Author: Alister Wolfisz
Issuing Office: Leeds
Issue Date: December 2004

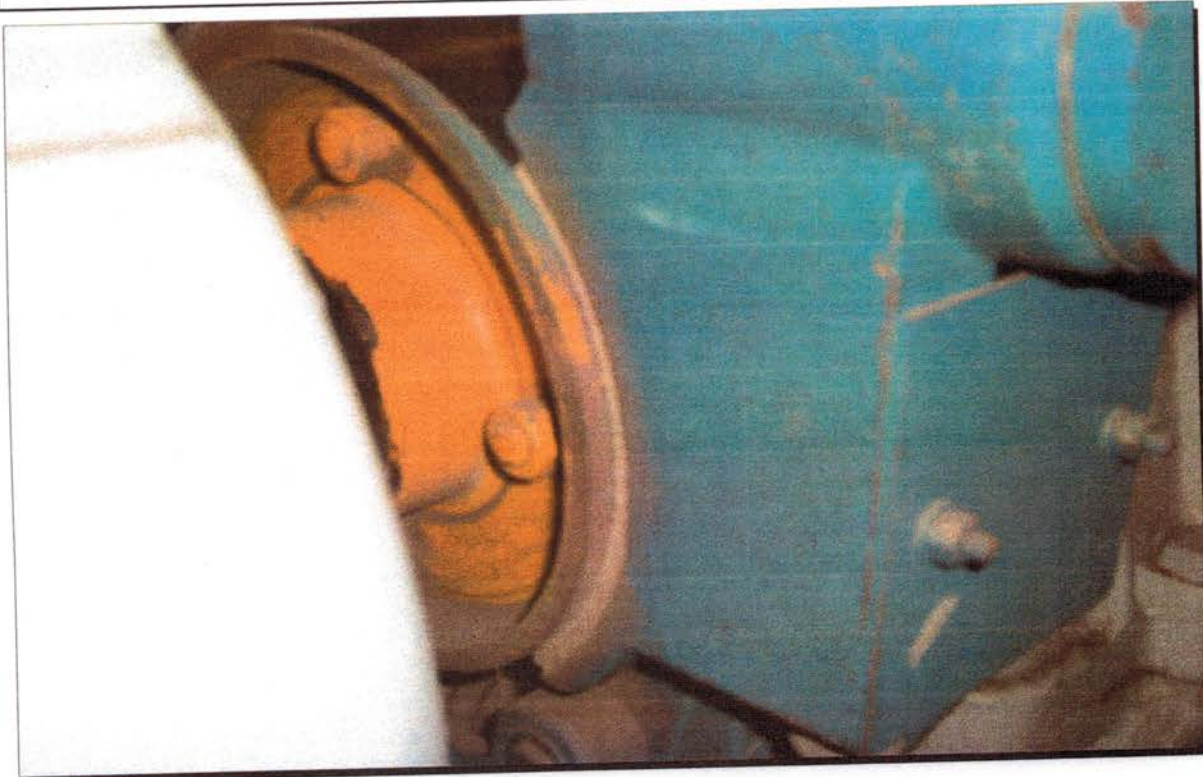
PRIORITY RATING							
Material	Analysis Result	Location	Condition	Exposed Population	Accessibility	Encapsulation/ sealant	Priority Rating
Friction Material	Chrysotile High	Internal	Fair-scratched/ marked surface	Unoccupied serviced	Difficult-concealed	Sealed/ reinforced	C

COMMENTS
Brake pads to 1 No. lift motor.

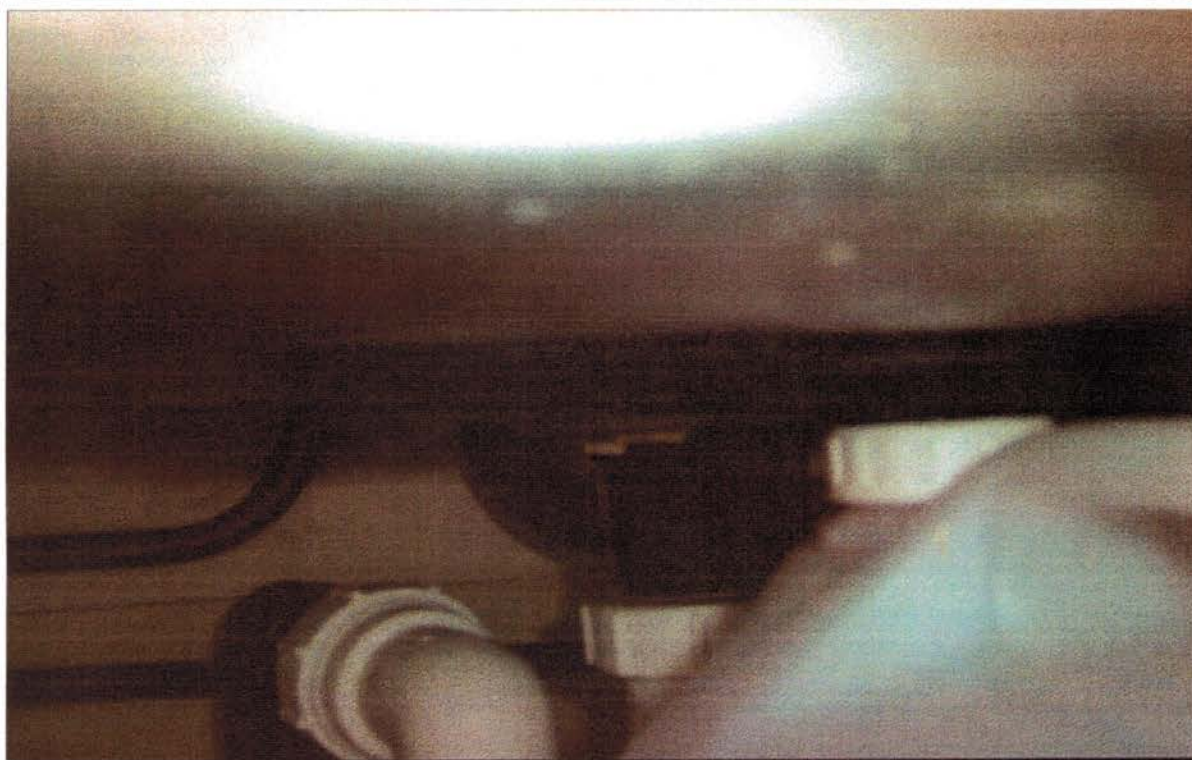
Sample Number:	S3143/002	Element:	Sink
		Quantity:	1 No.

1 No. bituminous sink pad.

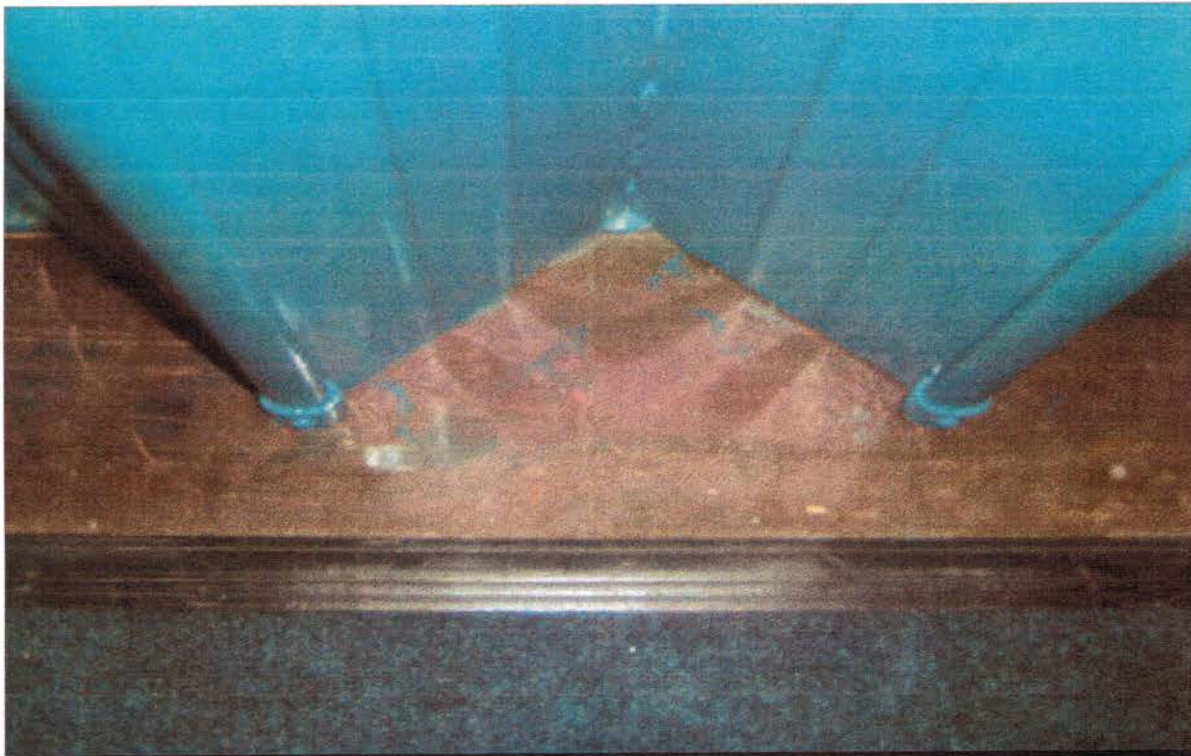
SAMPLING DETAILS		
Sample Number:	S3143/003	Element: Floor
		Quantity: 2 m2

LOCATION			
Block/ Unit No.	Room ID	Description	Floor
Vickers House	ST.01	Stairwell	Second

PRIORITY RATING							
Material	Analysis Result	Location	Condition	Exposed Population	Accessibility	Encapsulation/ sealant	Priority Rating
Vinyl products	NAD	Internal	Fair-scratched/ marked surface	Thoroughfare/ welfare	Easily	Sealed/ reinforced	N/A

COMMENTS
Brown vinyl floor tiles to lift presumed under carpet of laundry on 2nd, 1st, ground and present throughout stairwell.

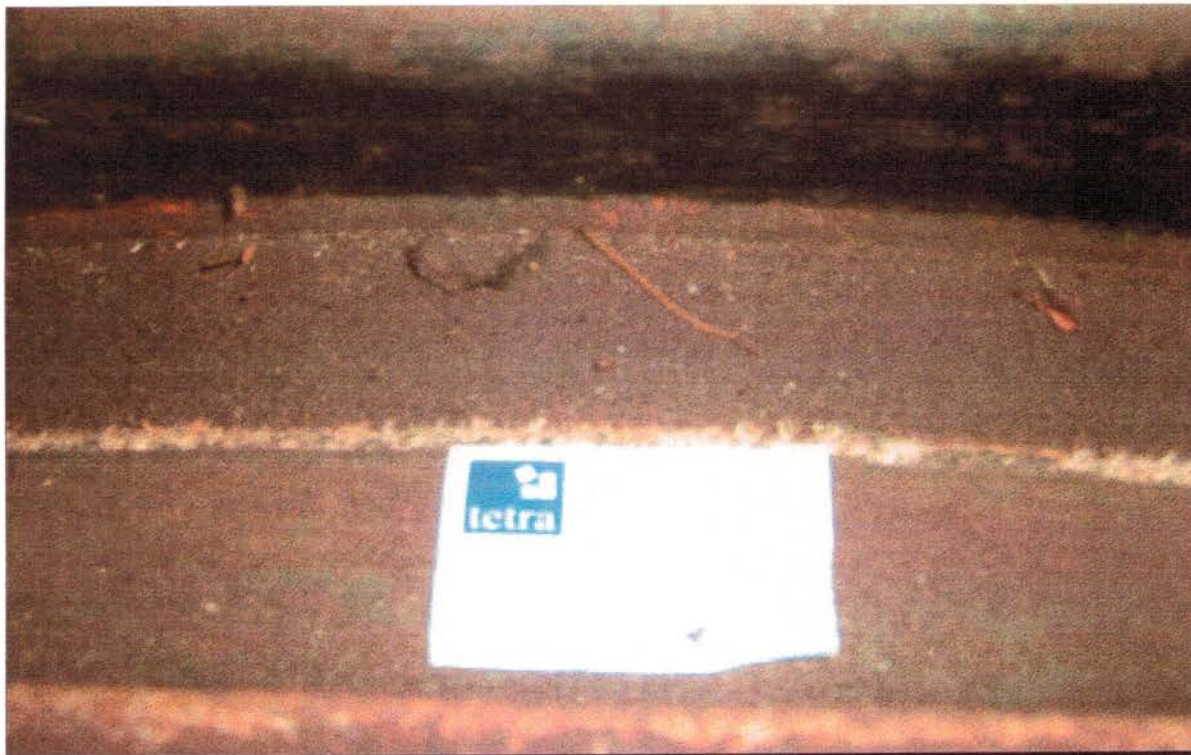
SAMPLING DETAILS		
Sample Number:	S3143/004	Element: Boiler
		Quantity: 4 m

LOCATION			
Block/ Unit No.	Room ID	Description	Floor
Vickers House	G.27	Boiler room	Ground

PRIORITY RATING							
Material	Analysis Result	Location	Condition	Exposed Population	Accessibility	Encapsulation/ sealant	Priority Rating
Gaskets (rope/woven)	Chrysotile High	Internal	Fair-scratched/ marked surface	Unoccupied serviced	Easily	None	C

COMMENTS
Rope gasket to "Nuway" boiler.

Sample No.	Location and Description	Priority Rating	Recommended Action	Comments
S3145/004	Asbestos rope gaskets in nunway boiler in boiler house (G.27)	C	<i>Label and manage in situ</i>	Prior to any works being carried out which may disturb the rope the material should be removed by a HSE licensed removal contractor.
S3143/005	Asbestos insulating board gasket to nunway boiler in boiler room (G.27)	C	<i>Label and manage in situ</i>	Prior to any works being carried out which may disturb the asbestos insulating board the material should be removed by a HSE licensed removal contractor.
Further Discussion:	Work on asbestos insulating board must be carried out by a HSE licensed removal contractor and is usually subject to a 14-day notification period.

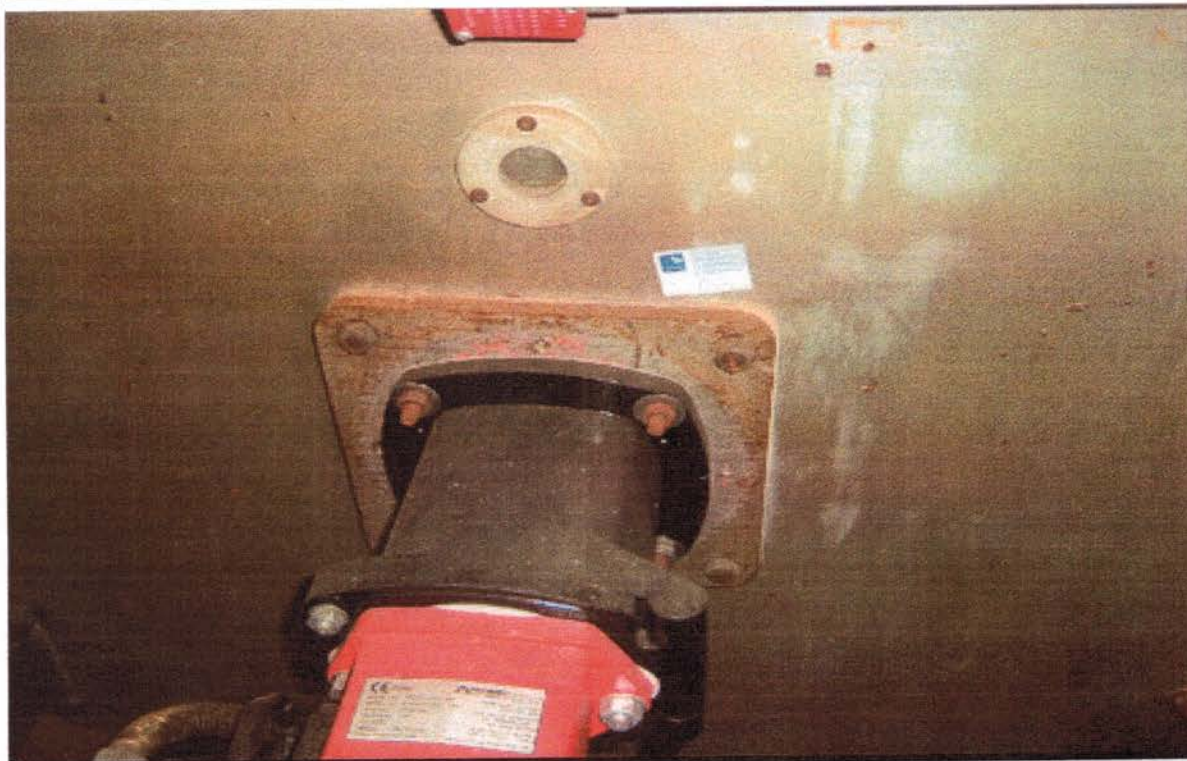
SAMPLING DETAILS		
Sample Number:	S3143/005	Element: Boiler
		Quantity: < 1 m2

LOCATION			
Block/ Unit No.	Room ID	Description	Floor
Vickers House	G.27	Boiler room	Ground

PRIORITY RATING							
Material	Analysis Result	Location	Condition	Exposed Population	Accessibilty	Encapsulation/ sealant	Priority Rating
Insulating board	Chrysotile High	Internal	Fair-scratched/ marked surface	Unoccupied serviced	Easily	None	C

COMMENTS
Insulating board gasket to "Nuway" boiler.

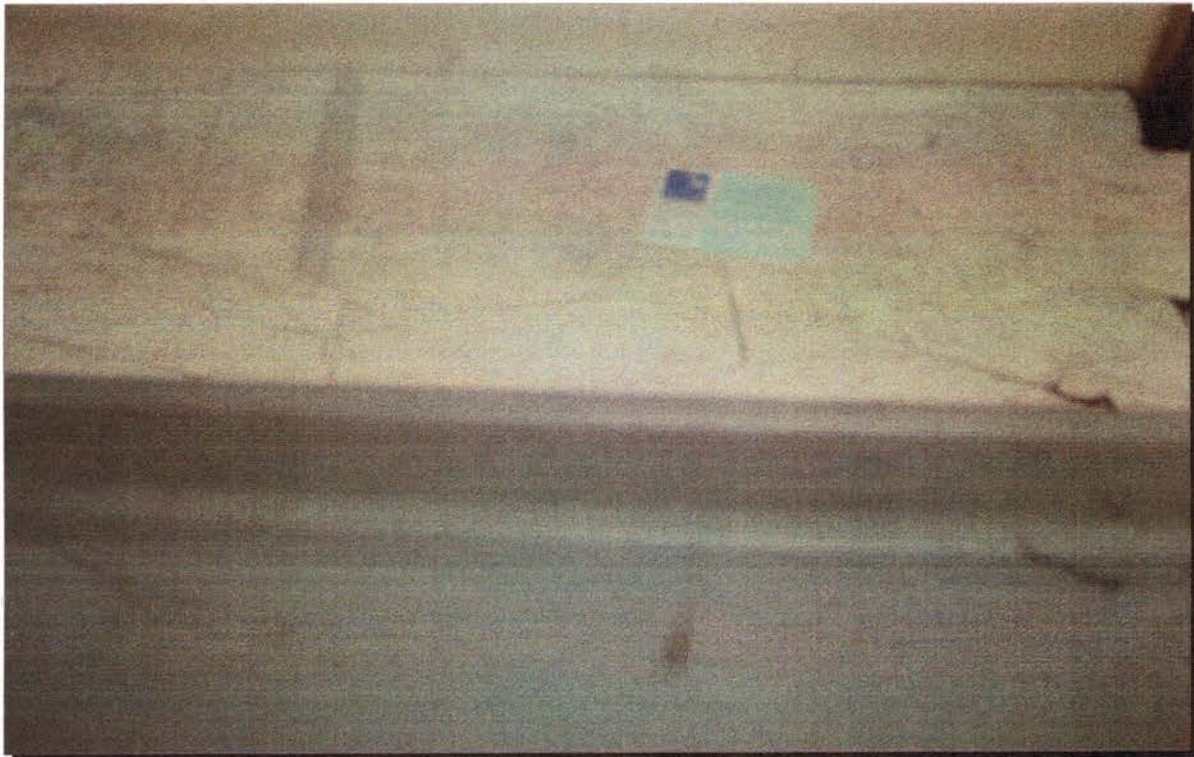
SAMPLING DETAILS		
Sample Number:	S3143/006	Element: Wall
		Quantity: 4 m2

LOCATION			
Block/ Unit No.	Room ID	Description	Floor
1	01.18	Meeting room	First

PRIORITY RATING							
Material	Analysis Result	Location	Condition	Exposed Population	Accessibilty	Encapsulation/ sealant	Priority Rating
Insulating board	NAD	Internal	Fair-scratched/ marked surface	Office area	Low-above suspended ceiling	None	N/A

COMMENTS
Supalux reveal above suspended ceiling above beam on wall by warehouse.

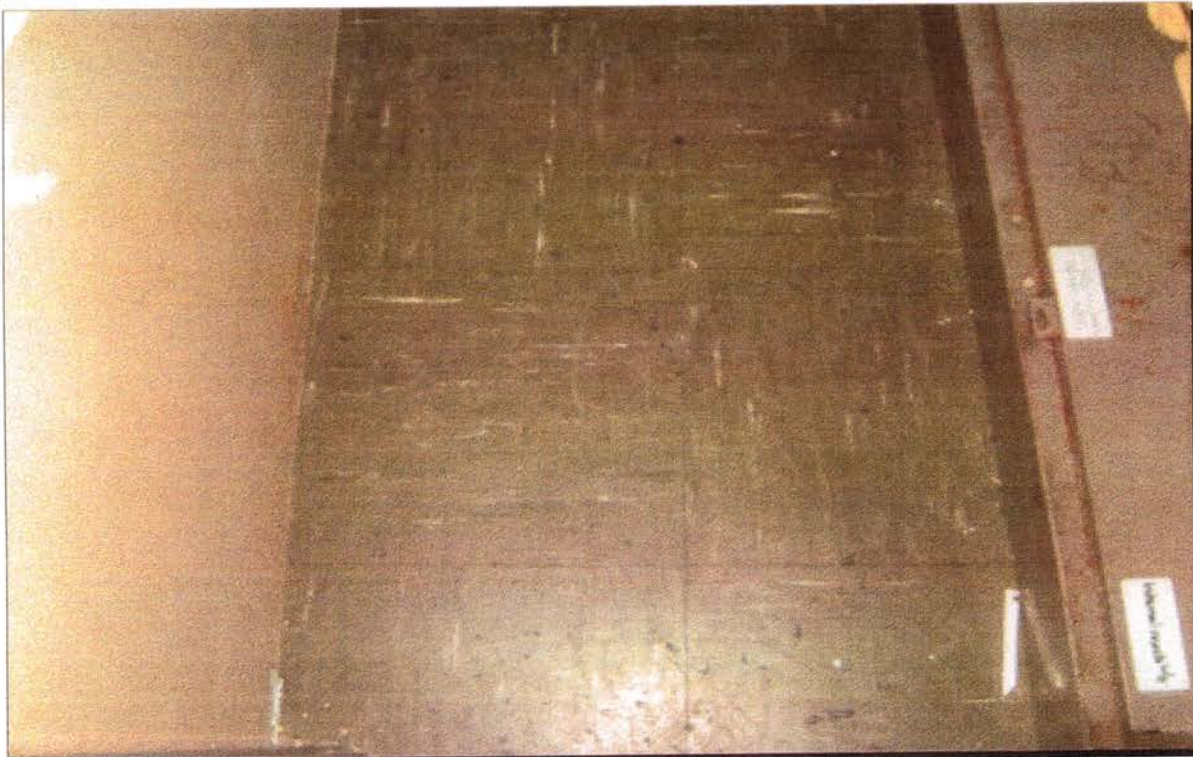
Sample Number:	S3143/007	Element:	Floor
		Quantity:	7 m2

Green and white dash vinyl floor tiles throughout. Presumed to continue into ST.03 landing area.

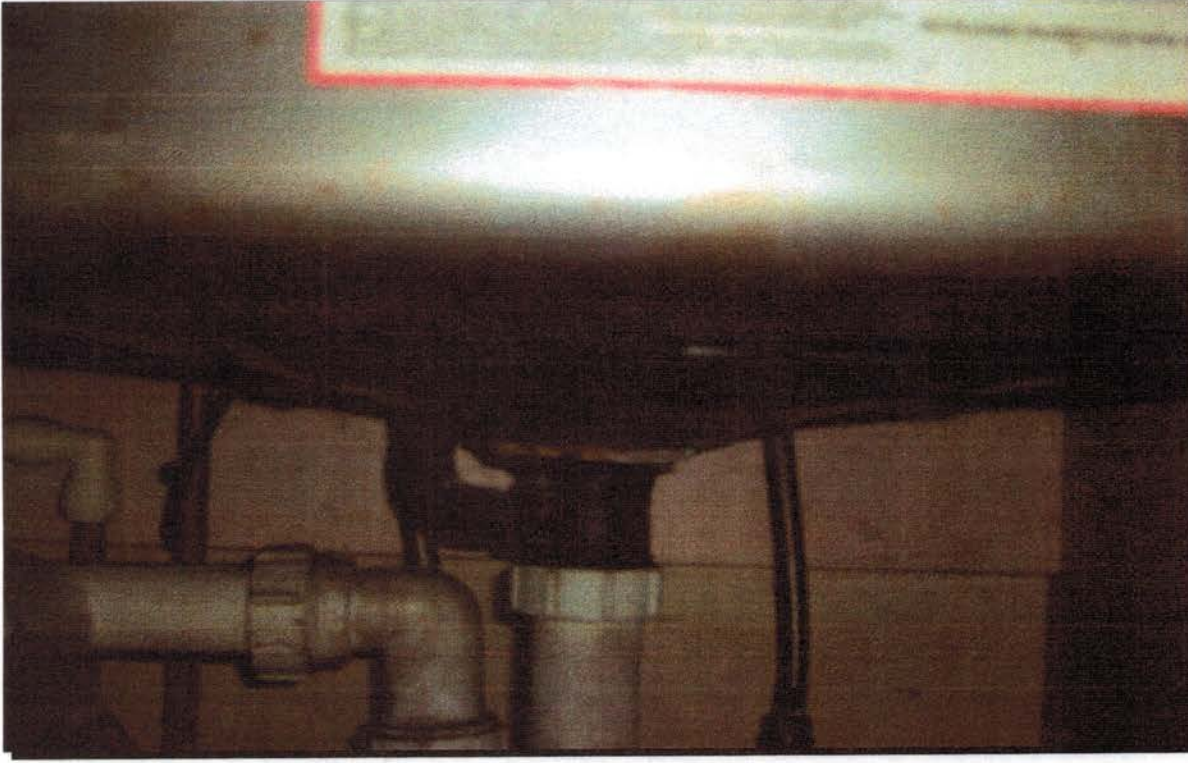
Sample Number:	S3143/008	Element:	Sink
		Quantity:	2 No.

2 No. perforated pads under sink unit.

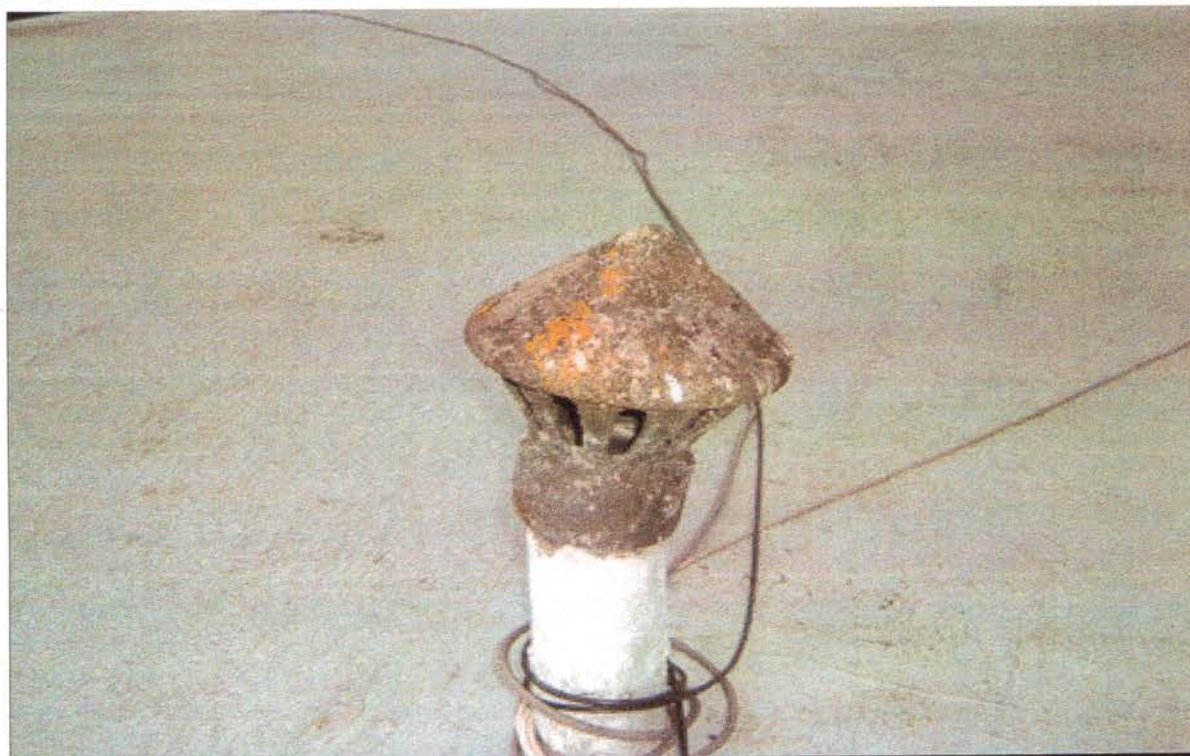
Sample Number:	S3143/009	Element:	Flue cap
		Quantity:	1 No.

Cement flue cap on top of metal pipe.

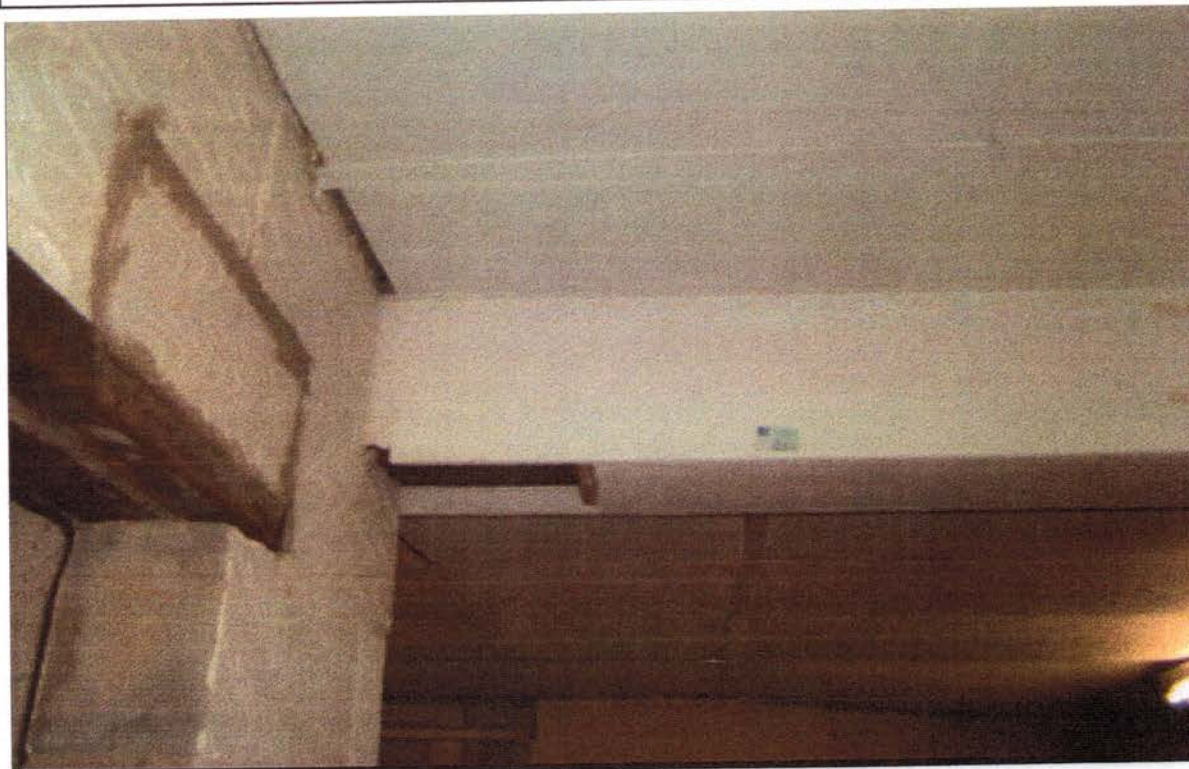
SAMPLING DETAILS		
Sample Number:	S3143/010	Element: Ceiling
		Quantity: 10 m2

Asbestos insulating board is present to beam on ceiling, in store/loading bay (G.54) Century House, requires removal by an HSE licensed contractor under controlled conditions within a 14-day notification period.

LOCATION			
Block/ Unit No.	Room ID	Description	Floor
Century House	G.54	Store/ loading bay	Ground

PRIORITY RATING							
Material	Analysis Result	Location	Condition	Exposed Population	Accessibility	Encapsulation/ sealant	Priority Rating
Insulating board	Amosite Medium, Chrysotile Trace	Internal	V.poor-badly/ severely damaged	Office area	Moderate- stepladder access	Paint sealed	B

COMMENTS
Asbestos insulating board to beam throughout.

Sample No.	Location and Description	Priority Rating	Recommended Action	Comments
S3143/010	Asbestos insulating board to beam throughout the ceiling in store/loading bay (G.54)	B	<i>Remove</i>	An HSE licensed removal contractor should remove the insulating board.
VI3143/528	Presumed CAF gaskets to pipe flanges throughout Boiler room (G.61)	C	<i>Manage in situ</i>	CAF gaskets should be removed prior to any works being carried out which may disturb the material. Removal should be subject to a risk assessment by a competent person to produce a suitable and sufficient plan of work to be followed by appropriately trained operatives to include for disposal as special waste.
VI3143/527	Presumed rope gaskets to 2No boilers in boiler room (G.61)	C	<i>Label and manage in situ</i>	Care should be taken not to disturb the asbestos materials during routine maintenance. Works should be subject to a risk assessment by a competent person to produce a suitable and sufficient plan of work to be followed by appropriately trained operatives to include for to include for disposal as special waste.

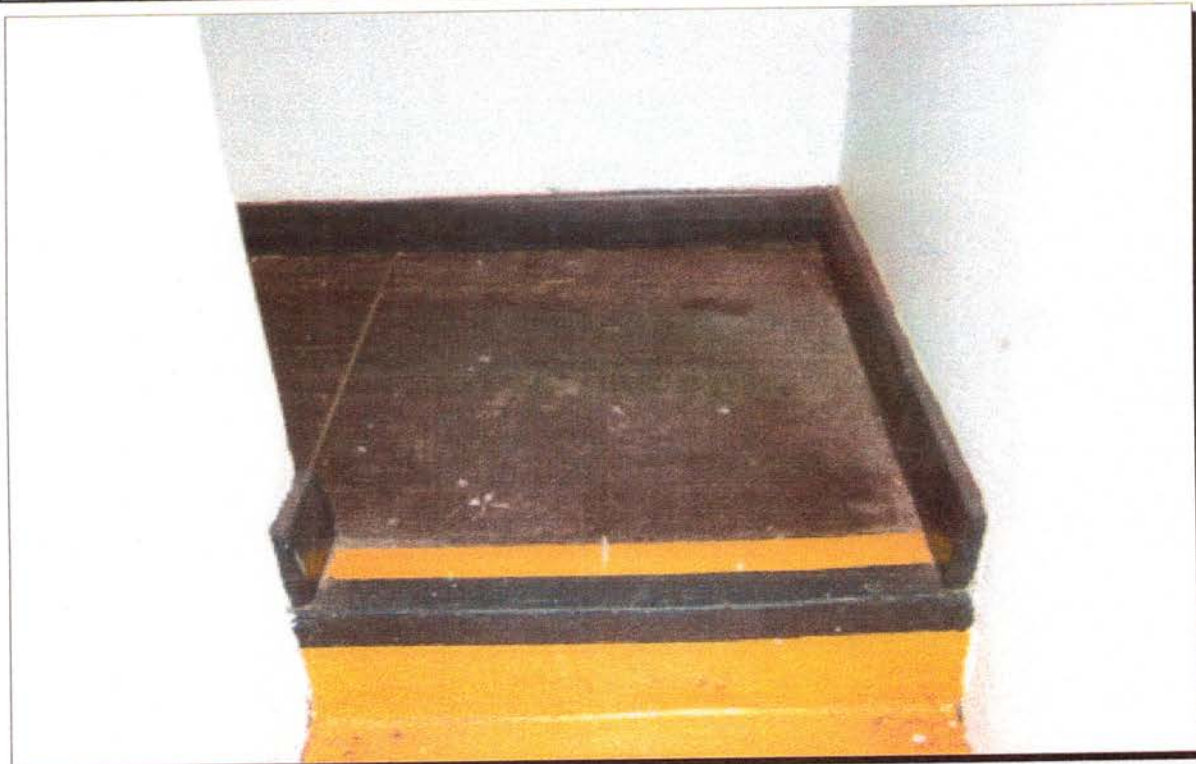
SAMPLING DETAILS		
Sample Number:	S3143/011	Element: Floor
		Quantity: 10 m2

LOCATION			
Block/ Unit No.	Room ID	Description	Floor
Century House	G.53	Store	Ground

PRIORITY RATING							
Material	Analysis Result	Location	Condition	Exposed Population	Accessibility	Encapsulation/ sealant	Priority Rating
Vinyl products	NAD	Internal	Fair-scratched/ marked surface	Office area	Easily	Sealed/ reinforced	N/A

COMMENTS
Blue and black vinyl floor tiles throughout.

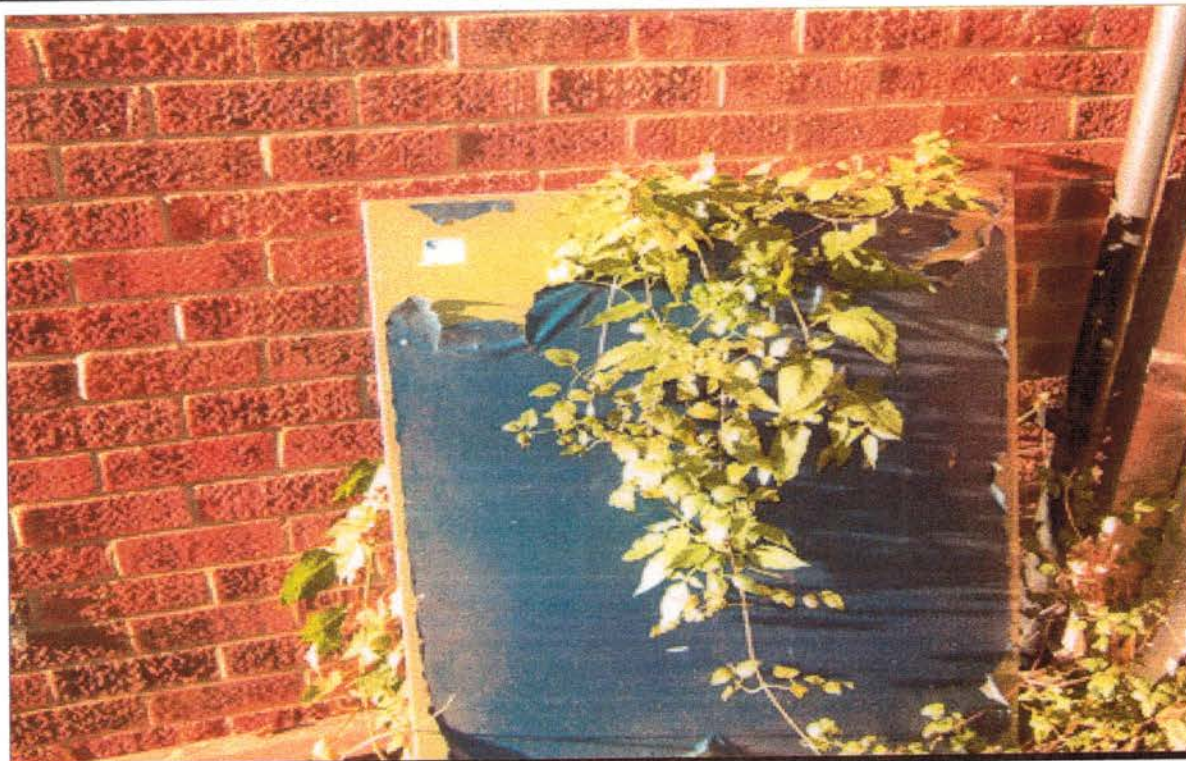
SAMPLING DETAILS		
Sample Number:	S3143/012	Element: Window
		Quantity: 70 m2

LOCATION			
Block/ Unit No.	Room ID	Description	Floor
Century House	E.03	External	Ground

PRIORITY RATING							
Material	Analysis Result	Location	Condition	Exposed Population	Accessibility	Encapsulation/ sealant	Priority Rating
Cement product	Chrysotile Medium, Amosite Trace	External	Fair-scratched/ marked surface	Unoccupied serviced	Easily	Paint sealed	C

COMMENTS
 Cement panels lining bottom section of windows on outside throughout, on ground and 1st floors. Double lining. 1 loose panel in picnic area.

S3143/012	Cement panels under windows to external area (E.03).	C	<i>Manage in-situ</i>	In the event of removal the cement should be disposed of as special waste.
Further Discussion:	Work on asbestos insulating board must be carried out by a HSE licensed removal contractor and is usually subject to a 14-day notification period. Access to live electrical boxes was not possible therefore a presumption of asbestos has been made. They should be managed as asbestos unless further investigations prove them to be asbestos free. Although work with cement does not require a license it is recommended that a HSE licensed contractor is used to carry out the works in accordance with the Control of Asbestos at Work Regulations 2002.

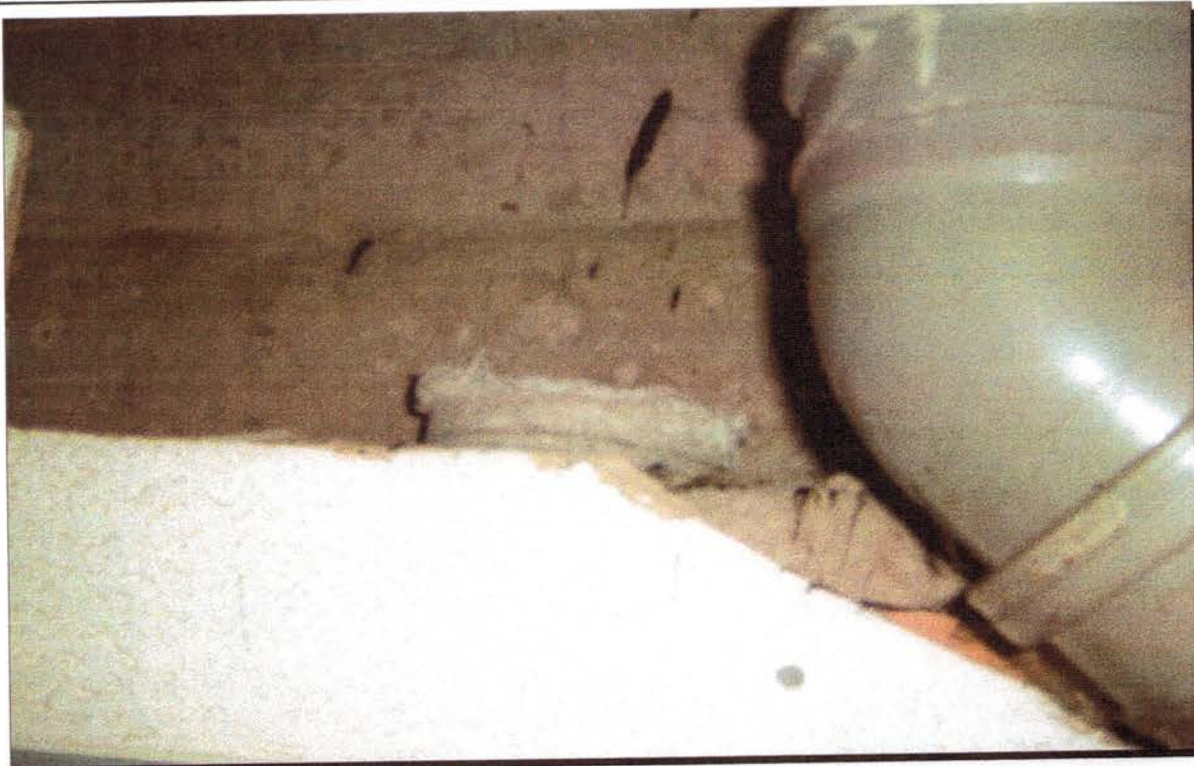
Sample Number:	S3143/013	Element:	Wall
		Quantity:	1 No.

Rope in cement matrix gasket, removed as sample.

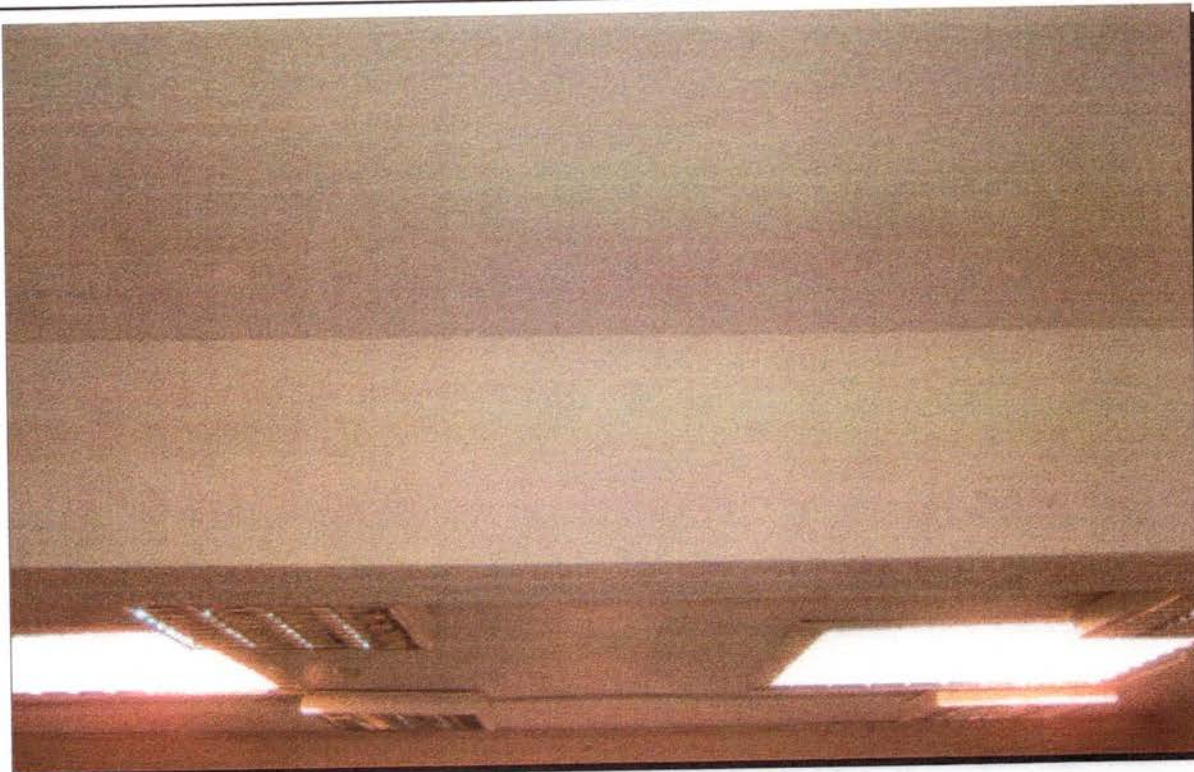
SAMPLING DETAILS		
Sample Number:	S3143/014	Element: Ceiling
		Quantity: 30 m2

Asbestos textured coating is present to ceiling throughout offices (G.90, G.91) Century House.

LOCATION			
Block/ Unit No.	Room ID	Description	Floor
Century House	G.90	Office	Ground

PRIORITY RATING							
Material	Analysis Result	Location	Condition	Exposed Population	Accessibilty	Encapsulation/ sealant	Priority Rating
Textured coating	Chrysotile Trace	Internal	Fair-scratched/ marked surface	Office area	Moderate- stepladder access	Paint sealed	C

COMMENTS
 Textured coating to ceiling throughout.

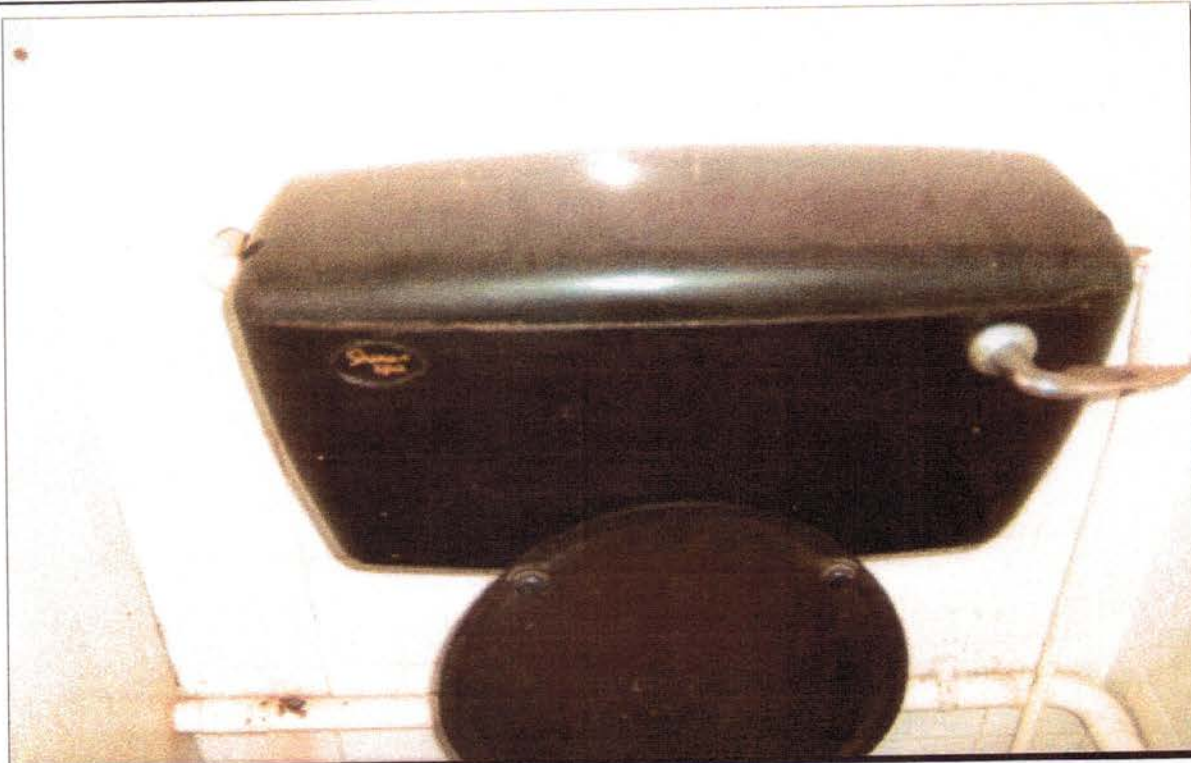
SAMPLING DETAILS		
Sample Number: S3143/015	Element:	Toilet
	Quantity:	1 No.

LOCATION			
Block/ Unit No.	Room ID	Description	Floor
3b	G.95	Toilet and lobby	Ground

PRIORITY RATING							
Material	Analysis Result	Location	Condition	Exposed Population	Accessibility	Encapsulation/ sealant	Priority Rating
PVC/Reinforced plastics	Amosite Medium	Internal	Fair-scratched/ marked surface	Thoroughfare/ welfare	Easily	Sealed/ reinforced	C

COMMENTS
1 No. shire black toilet cistern.

Sample No.	Location and Description	Priority Rating	Recommended Action	Comments
S3143/015	Asbestos black shire toilet cistern in toilet and lobby (G.95)	C	<i>Label and manage in situ</i>	In the event of removal the toilet cistern should be disposed of as special waste.
Further Discussion:	The toilet cistern is low in friability and not likely to be disturbed thus posing a low risk.

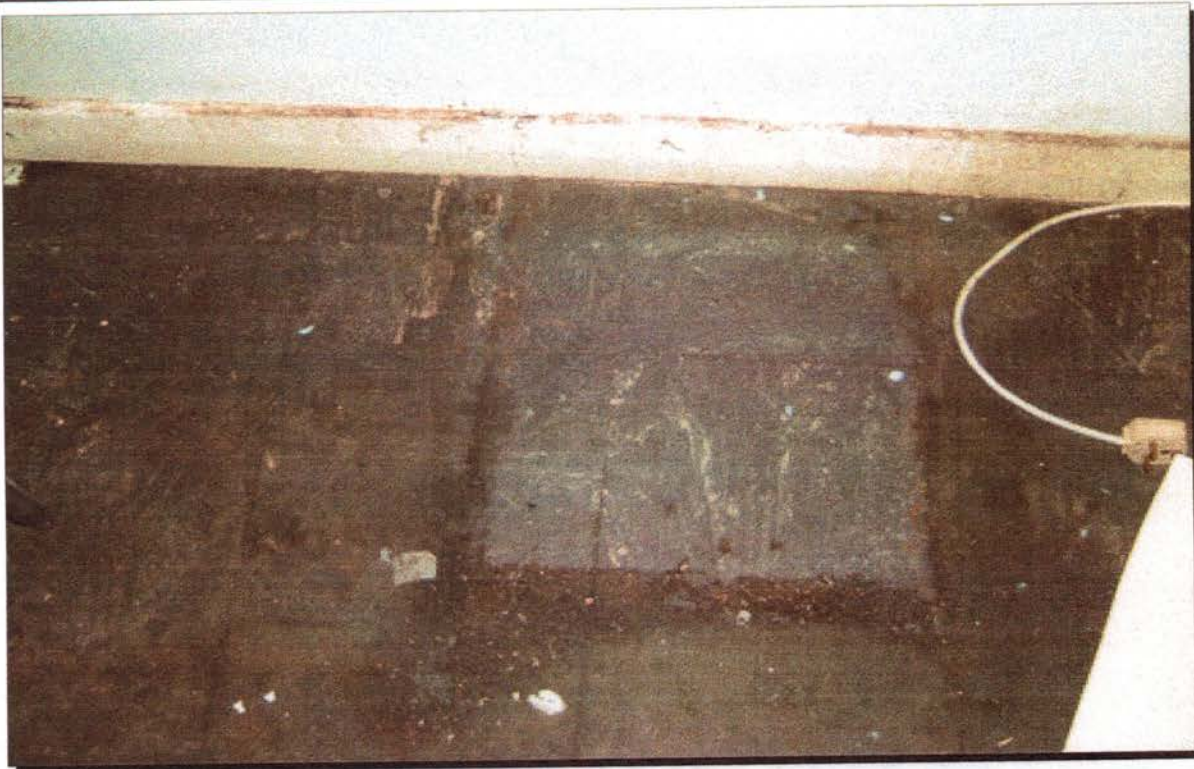
SAMPLING DETAILS		
Sample Number: S3143/016	Element:	Floor
	Quantity:	9 m2

LOCATION			
Block/ Unit No.	Room ID	Description	Floor
3b	G.96	Kitchen	Ground

PRIORITY RATING							
Material	Analysis Result	Location	Condition	Exposed Population	Accessibility	Encapsulation/ sealant	Priority Rating
Vinyl products	NAD	Internal	Fair-scratched/ marked surface	Thoroughfare/ welfare	Easily	Sealed/ reinforced	N/A

COMMENTS
Black and white vinyl floor tiles throughout.

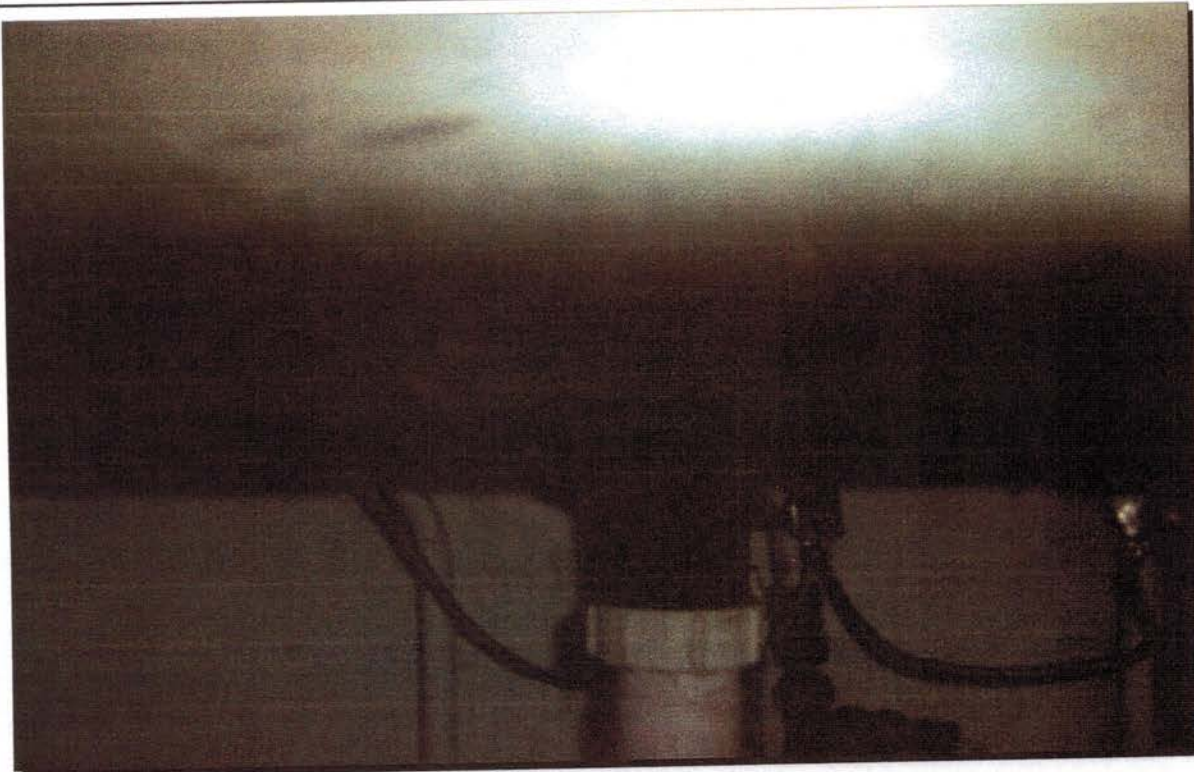
SAMPLING DETAILS		
Sample Number:	S3143/017	Element: Floor
		Quantity: 1 No.

LOCATION			
Block/ Unit No.	Room ID	Description	Floor
3b	G.96	Kitchen	Ground

PRIORITY RATING							
Material	Analysis Result	Location	Condition	Exposed Population	Accessibilty	Encapsulation/ sealant	Priority Rating
Bituminous product	NAD	Internal	Poor-localised damage	Thoroughfare/ welfare	Easily	Sealed/ reinforced	N/A

COMMENTS
Bituminous pad to under side of sink unit.
