LEGIONELLA RISK ASSESSMENT

Vickers Business Park

RA Report:

ASSESSMENT NO.: 6372
ASSESSMENT DATE: 25/04/2017

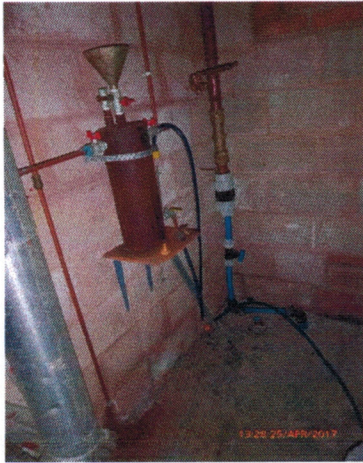
Photo 1:
Incoming mains and stop tap

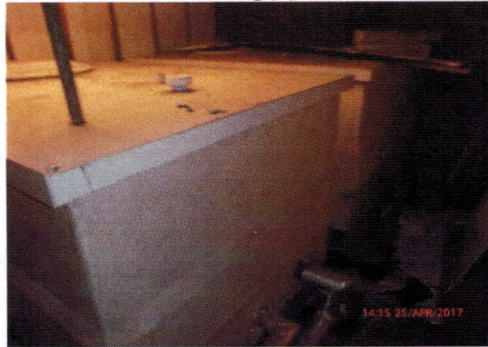
Photo 2:
CWST 1 in Century house, Open vent from the calorifier and no warning pipe

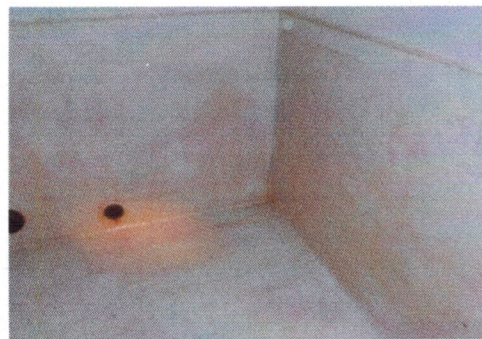
Photo 3:
Internal surfaces of CWST 2

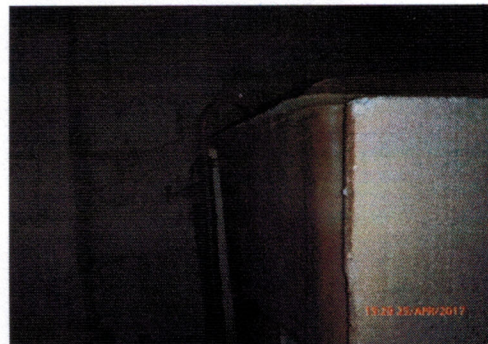
5	The cold water storage tank 2 (CWST) has a loose lid. Please refer to Section 8, Photo 4	An unsecured lid may allow insect and vermin ingress subsequently contaminating stored water.	Secure and fasten existing lid to tank and log details of all remedial action carried out.	HIGH	3

Item Ref	Findings	Risk	Recommended Action	Rating	Task Priority	Action Completed
6	Cold water storage tank 2 (CWST) is poorly insulated. Please refer to Section 8, Photo 4	All CWSTs should be thermally insulated to prevent stored water temperatures rising above 20°C and into the bacterial proliferation zone.	Insulate CWST. Log all details of work and monitoring carried out.	HIGH	3	
7	Cold water storage tank 2 has the inlet and outlets on the same side Please refer to Section 8, Photo 4	Positioning the inlet and outlet closely together or on the same side does not allow good cross flow and creates pockets of stagnation where bacteria may proliferate.	Fit internal sparge pipe and log details of remedial action.	HIGH	2	
8	Access to cold water storage tank 2 (CWST) is difficult and intrusive for monitoring. Please refer to Section 8, Photo 4	All cold water storage tanks should be in a cool area with adequate access for appropriate monitoring. The CWST should be inspected visually, internally and externally and cleaned and disinfected where necessary.	Improve access and implement appropriate monitoring. All remedial action must be logged.	MEDIUM	3

Photo 4:
CWST 2 in Lada with open vent, inlets & outlets on the same side and a loose lid.

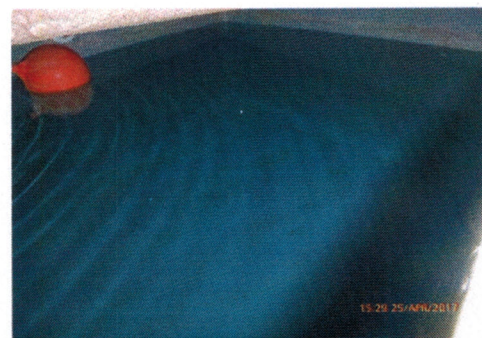
Photo 5:
Internal surface of CWST 2

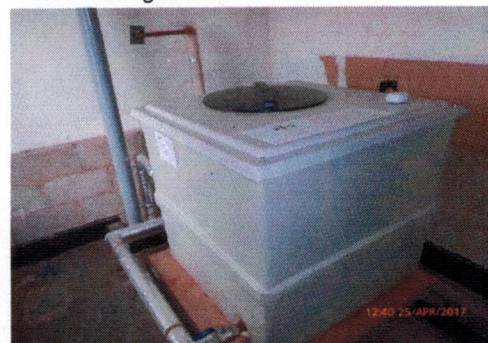
Photo 6:
CWST 3 in Vickers House with 1 redundant outlet feeding a decommissioned calorifier

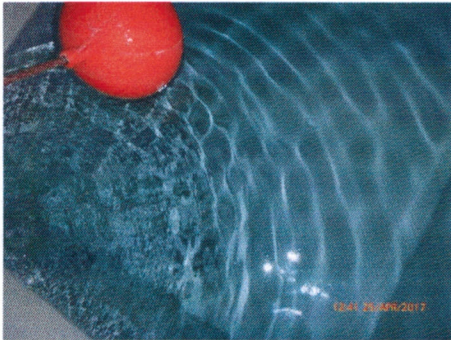
Photo 7:
Internal surfaces of CWST 3

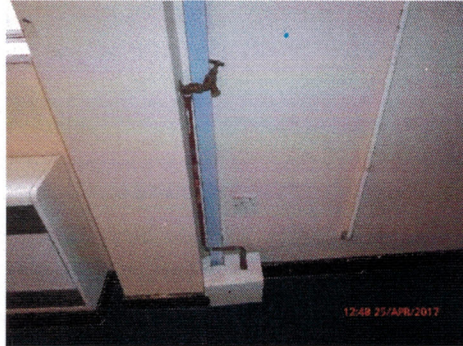
Item Ref	Findings	Risk	Recommended Action	Rating	Managed	Frequency	Action Completed
1	Infrequently used outlets on site including bib taps. Please refer to Section 8, Photo 8	Water may stagnate in the pipe work providing an environment for bacterial growth which may contaminate the mains supply.	Develop and log a flushing regime where all infrequently used outlets are flushed for 2 minutes on a weekly basis.	MEDIUM	YES	Weekly	Continue with monitoring
2	Hot and Cold sentinel outlets on site require monitoring.	Bacteria can readily multiply in water systems that are within a temperature range of between 20°C and 50°C, however should temperatures exceed 60°C scalding may occur.	Check and record hot water temperatures at sentinel outlets or at input to TMVs on a sentinel basis. Temperatures should be between 50°C - 55°C. The outlet from a TMV must not exceed 43°C. Carry out and log remedial action if temperatures outside of recommended range.	MEDIUM	YES	Monthly	Continue with monitoring

Photo 8:
Example of infrequently used bib tap.

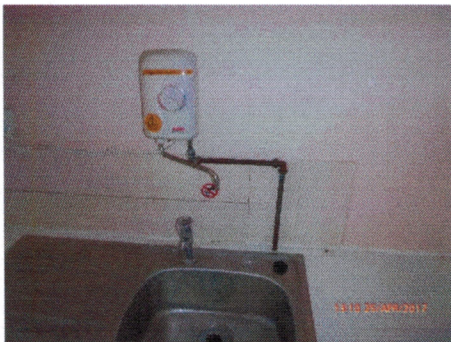
Photo 9:
Broken water heater in Vickers 1st floor Kitchen

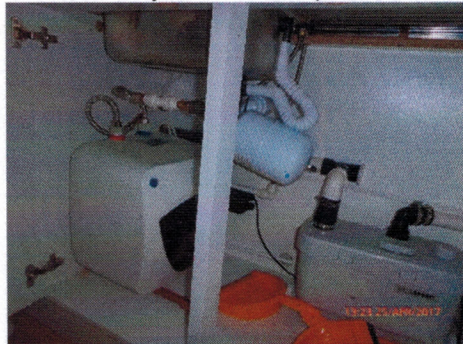
Photo 10:
Water heater in Vickers ground floor Cleaners with a sideways orientated expansion vessel

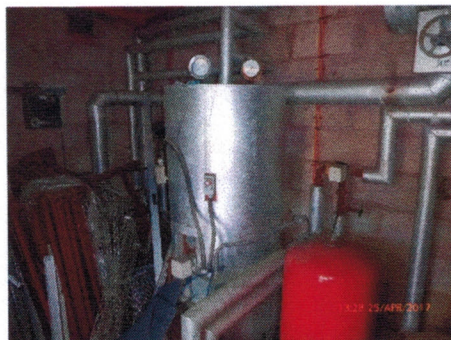
Photo 11:
Redundant calorifier in Vickers house connected to CWST 3

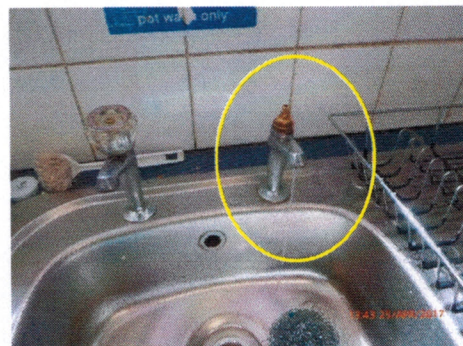
Photo 12:
Example of faulty outlets in the canteen

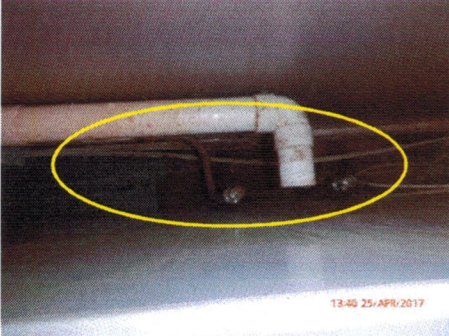
Photo 13:
Deadends in the Kitchen store room behind a chest freezer

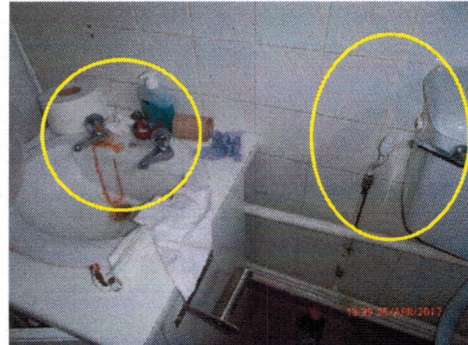
Photo 14:
Outlets disconnected in the Kitchen toilet

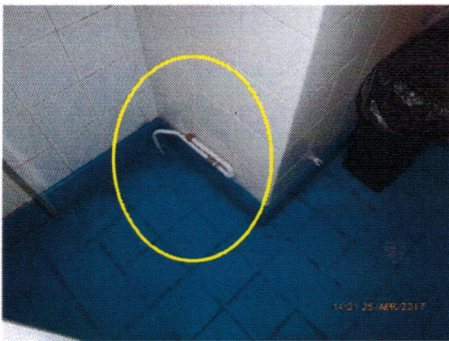
Photo 15:
Deadend in Century house 1st floor Female toilet

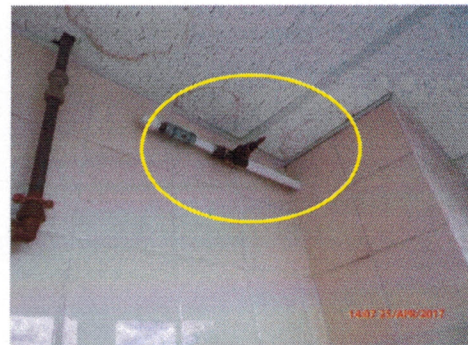
Photo 16:
Deadend in Century house 1st floor male toilet

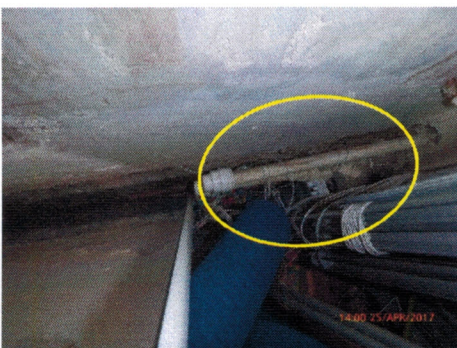
Photo 17:
Deadend in Century house 1st floor store cupboard

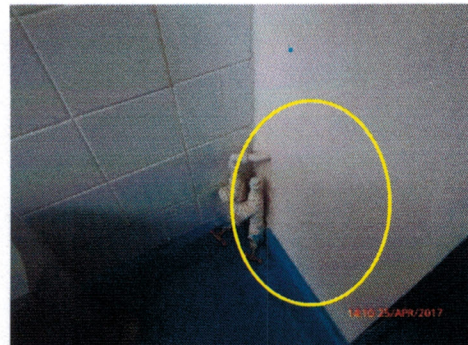
Photo 18:
Deadend in Century house 1st floor Female toilet

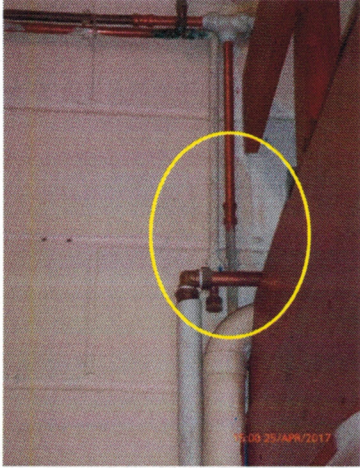
Photo 19:
Deadend in Lada canteen area above
Male toilet

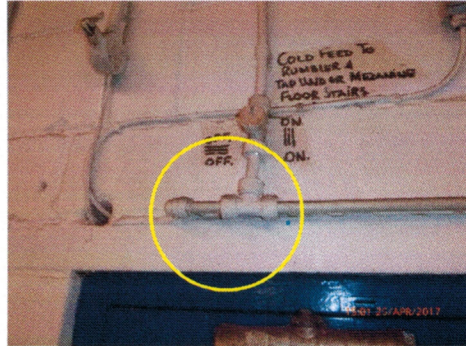
Photo 20:
Deadend in Lada factory

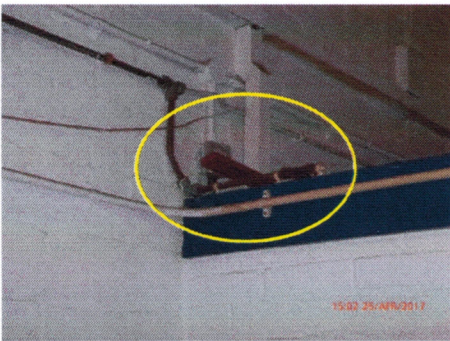
Photo 21:
Deadend above Lada toilet

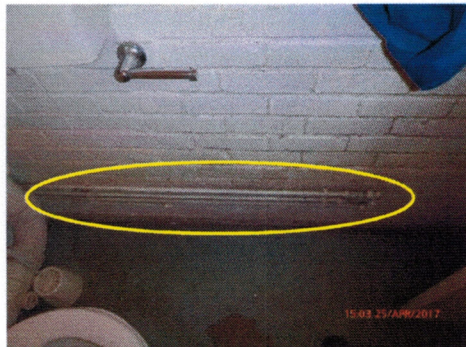
Photo 22:
Deadend in Lada factory toilet

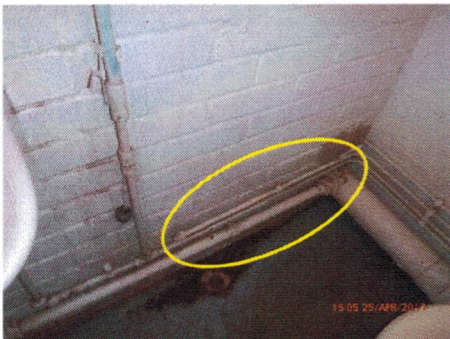
Photo 23:
Deadend in Lada factory toilet

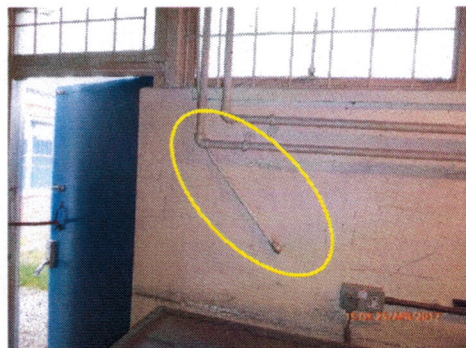
Photo 24:
Deadend in Lada polish room

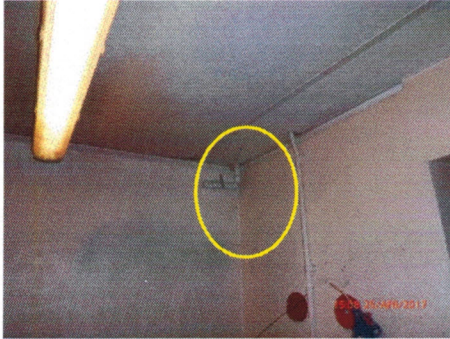
Photo 25:
Deadend in Lada polish room

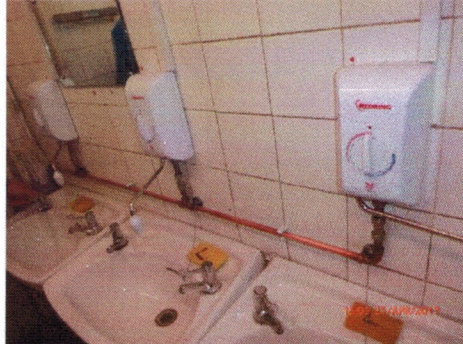
Photo 26:
3 water heaters in Lada workshop toilet that are connected and now redundant

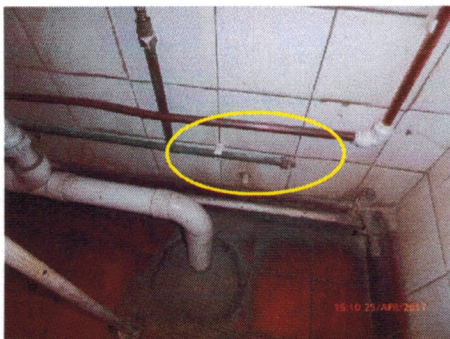
Photo 27:
Deadend in Lada factory toilet

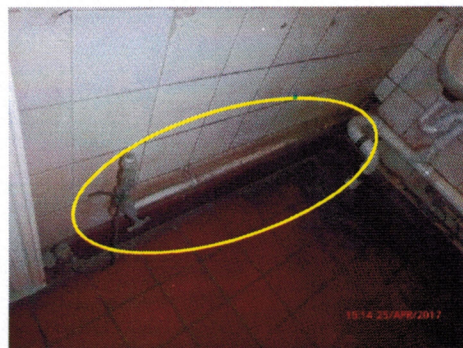
Photo 28:
Deadend in Lada factory toilet

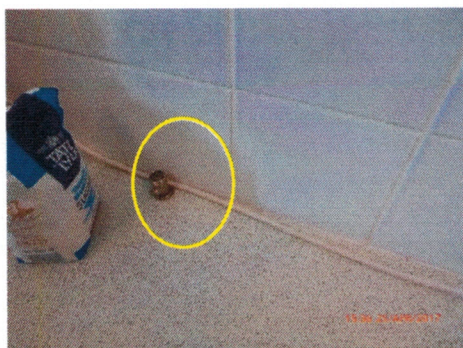
Photo 29:
Deadend in 1st floor Lada Kitchen
